Repair of Lock Gates at Cullen Bay Marine, Australia

AN OPEN & SHUT CASE GATE

Cullen Bay Marina project proves an open and shut case for underwater wet welding.

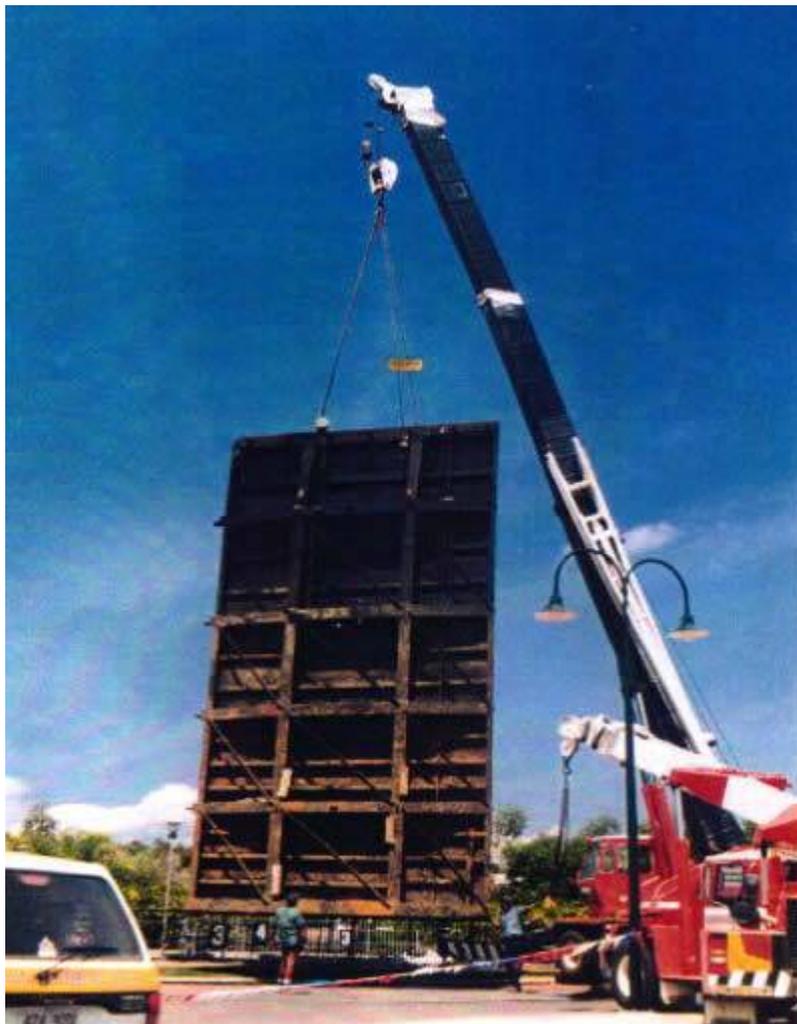
Figure 1 shows one of the gates. Each gate weighs over 12 tonnes and stands some 15 metres high. The gates consisted of a total of five hinge brackets, secured to the door via a hinge pin and then welded to a steel channel in the side of the concrete lock wall. The first task was to remove the pins from each gate, to allow the door to be removed out of the lock altogether. This involved the use of a number of heavy cranes.

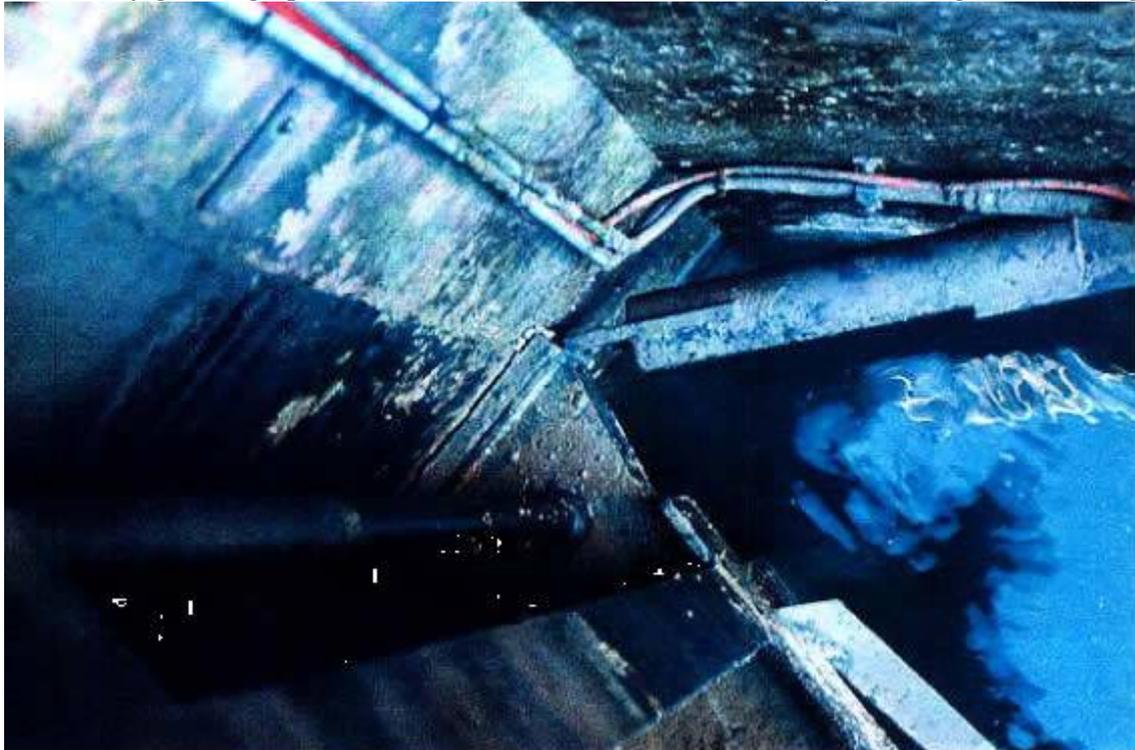
After suffering a number of constructional and operational mishaps, the lock gates at Cullen Bay Marina in Darwin, Northern Territories, in Australia finally gave up the ghost. Local diving specialists Tim Proctor of Territory Diving was asked to evaluate their repair. “We had a stroke of luck here,” said Tim. “I knew David Keats, the underwater wet welding expert was in the country, opening a new training center in Perth, Western Australia. I was very much aware of David’s reputation in the field. As the author of the UK’s National Qualification and The Professional Divers Manual on Wet Welding, I knew he was the man for the job and asked him to advise us on the suitability of wet welding”.

Figure 2 shows one of the failed hinge brackets in situ.

Then the task of removing the damaged hinges from the wall began. This involved divers cutting away the damaged weld using hydraulic grinders and air tools. Once all the hinges were removed these were machined up and the hinges were re-used. While this process was taking place, Tim's divers were busy grinding up the old welds on the channel faces, ready for fitting the new hinges.

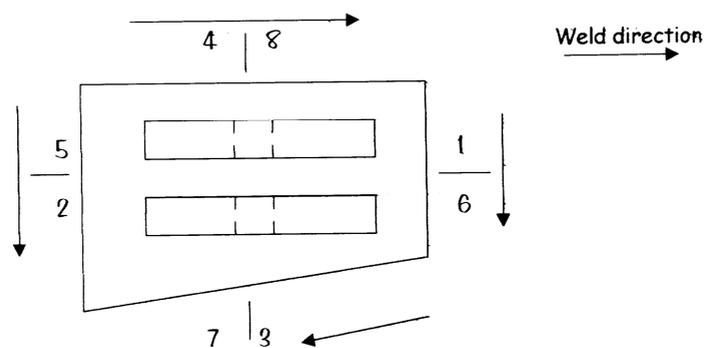
The actual preparation of the hinge bracket and the welding sequence was as shown above.

The bracket was cut back in this way, to aid overhead welding. In this way, the bubbles generated from the burning electrode could escape without interfering with the welding arc. The root and hot pass welding sequence, was conducted in a series of 8 blocks so as to minimise stresses and distortion. Once these two passes had been completed the welding followed a similar pattern, but attempts were made to ensure as few stop/starts as possible. The total number of passes was 9 for each bracket. This allowed for a 12-mm leg length to be produced as shown below.

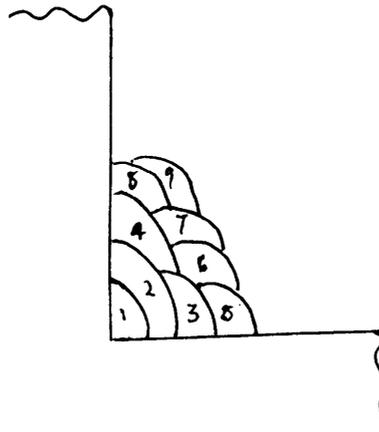
Figure 4 shows a sketch of the number and location of weld passes.

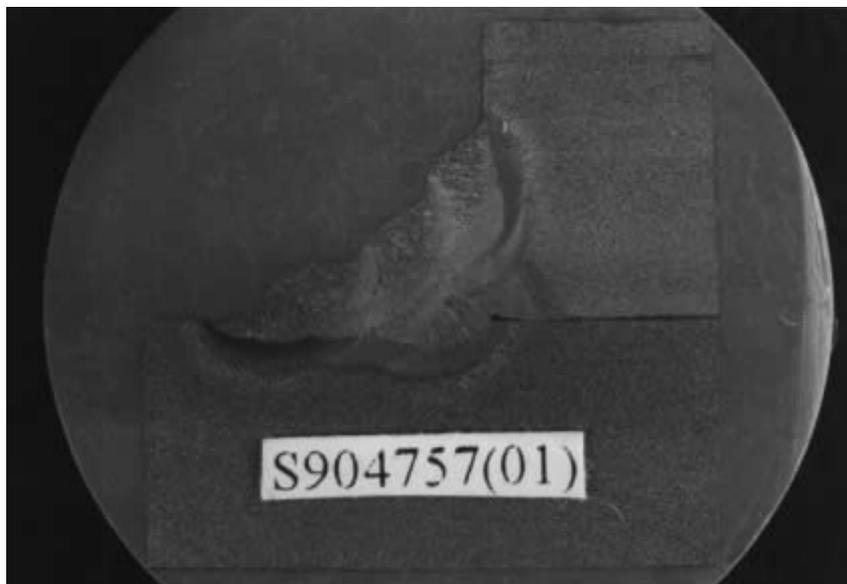
Figure 5. Shows a macro photo of the weld at (x3.4) magnification.
